## MINUTES OF THE MAY 20, 2009 REGULAR MEETING OF THE PUEBLO CONSERVANCY DISTRICT

## Flood Damage Reduction Segment / System Inspection Report

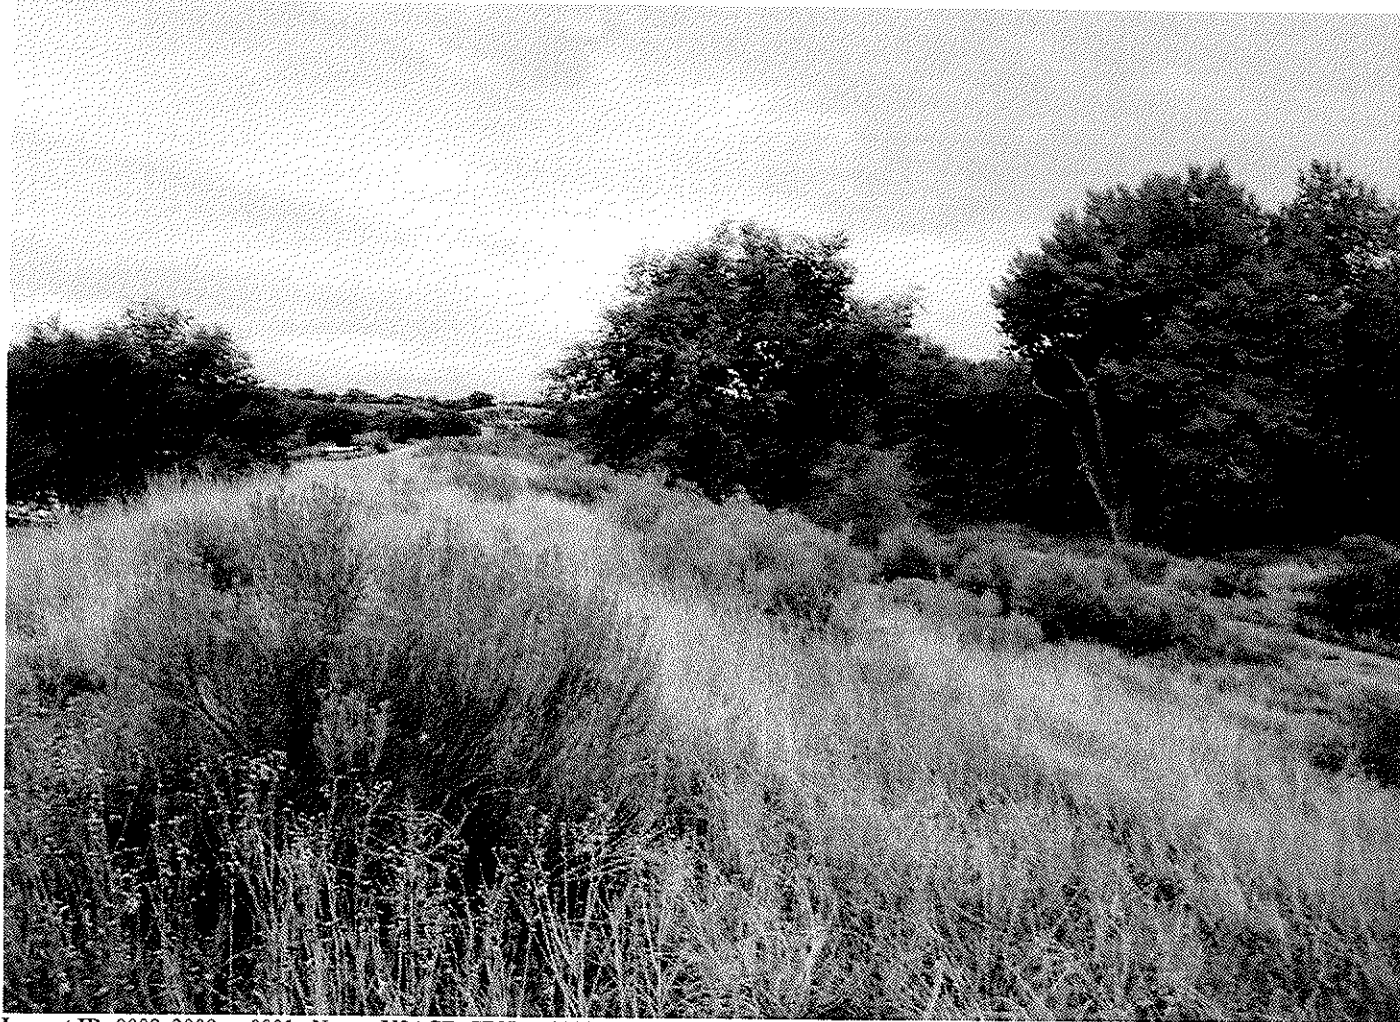
Inspect ID: 0008\_2008\_a\_0001 Name: USACE\_CESPA\_0008\_2008\_a\_0001\_1.jpg Caption: Bushes on levee crest and trees at toe.

All tree and shrub growth on the riverside and landside slopes and within 15 feet of the landside and riverside levee toe needs to be removed. Cut vegetation with stump diameter four inches or less flush with the ground and treat the stump to retard stump and root ball decay. Remove all trees having stump diameters greater than four inches including root balls, and backfill all voids with compacted impervious fill. If judged necessary, install filters and drain systems in root ball cavities where seepage, boiling, or piping is likely to occur.

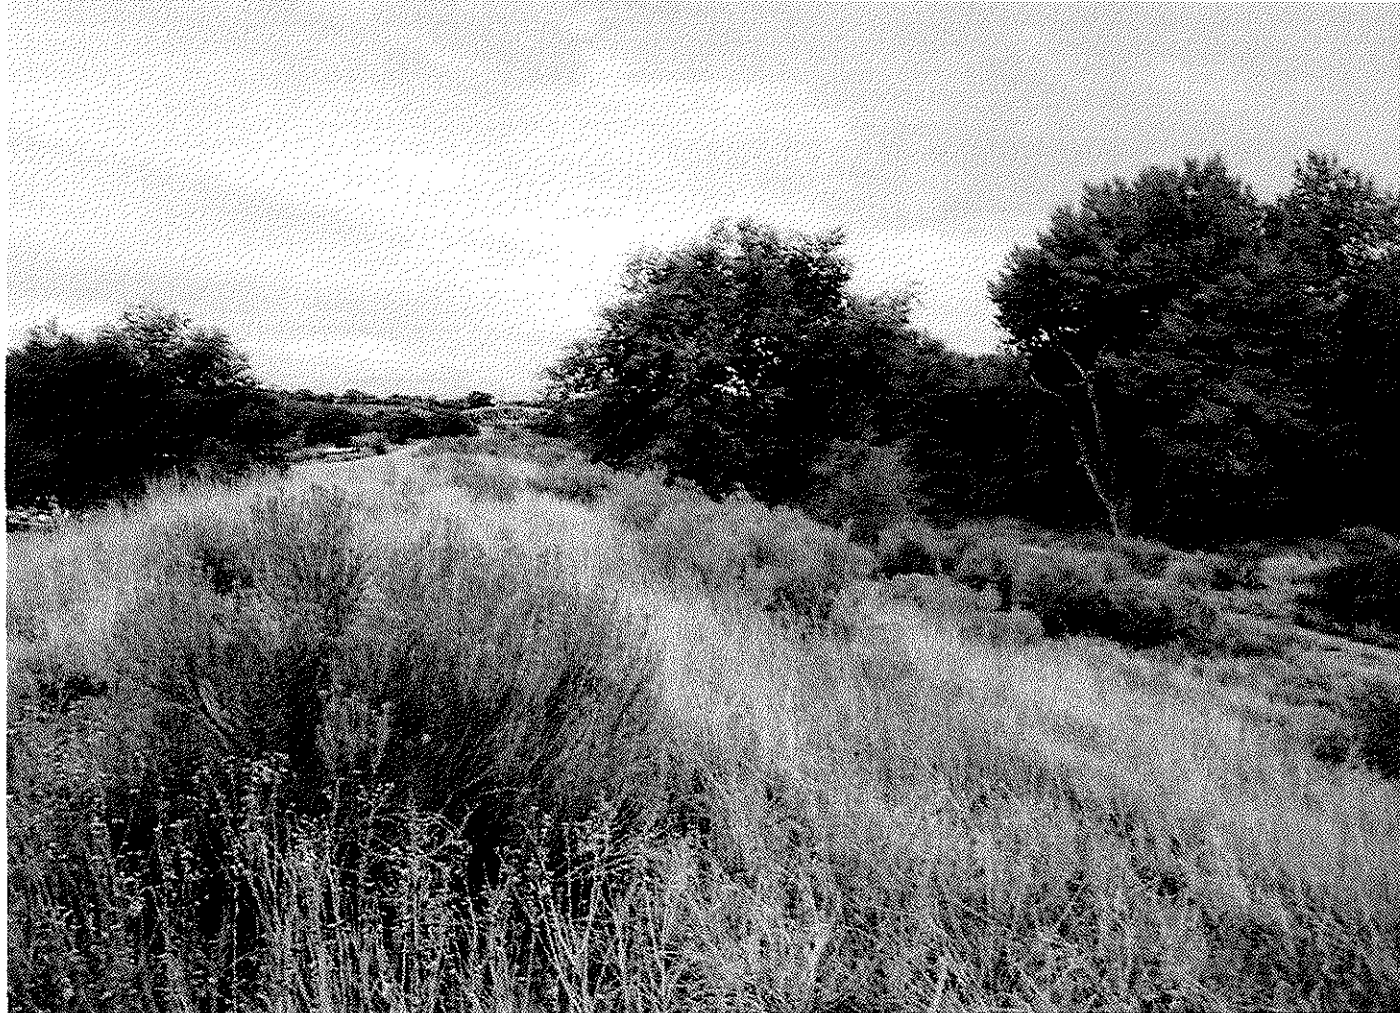
Inspect ID: 0008\_2008\_a\_0001 Name: USACE\_CESPA\_0008\_2008\_a\_0001\_1.jpg Caption: Bushes on levee crest and trees at toe.

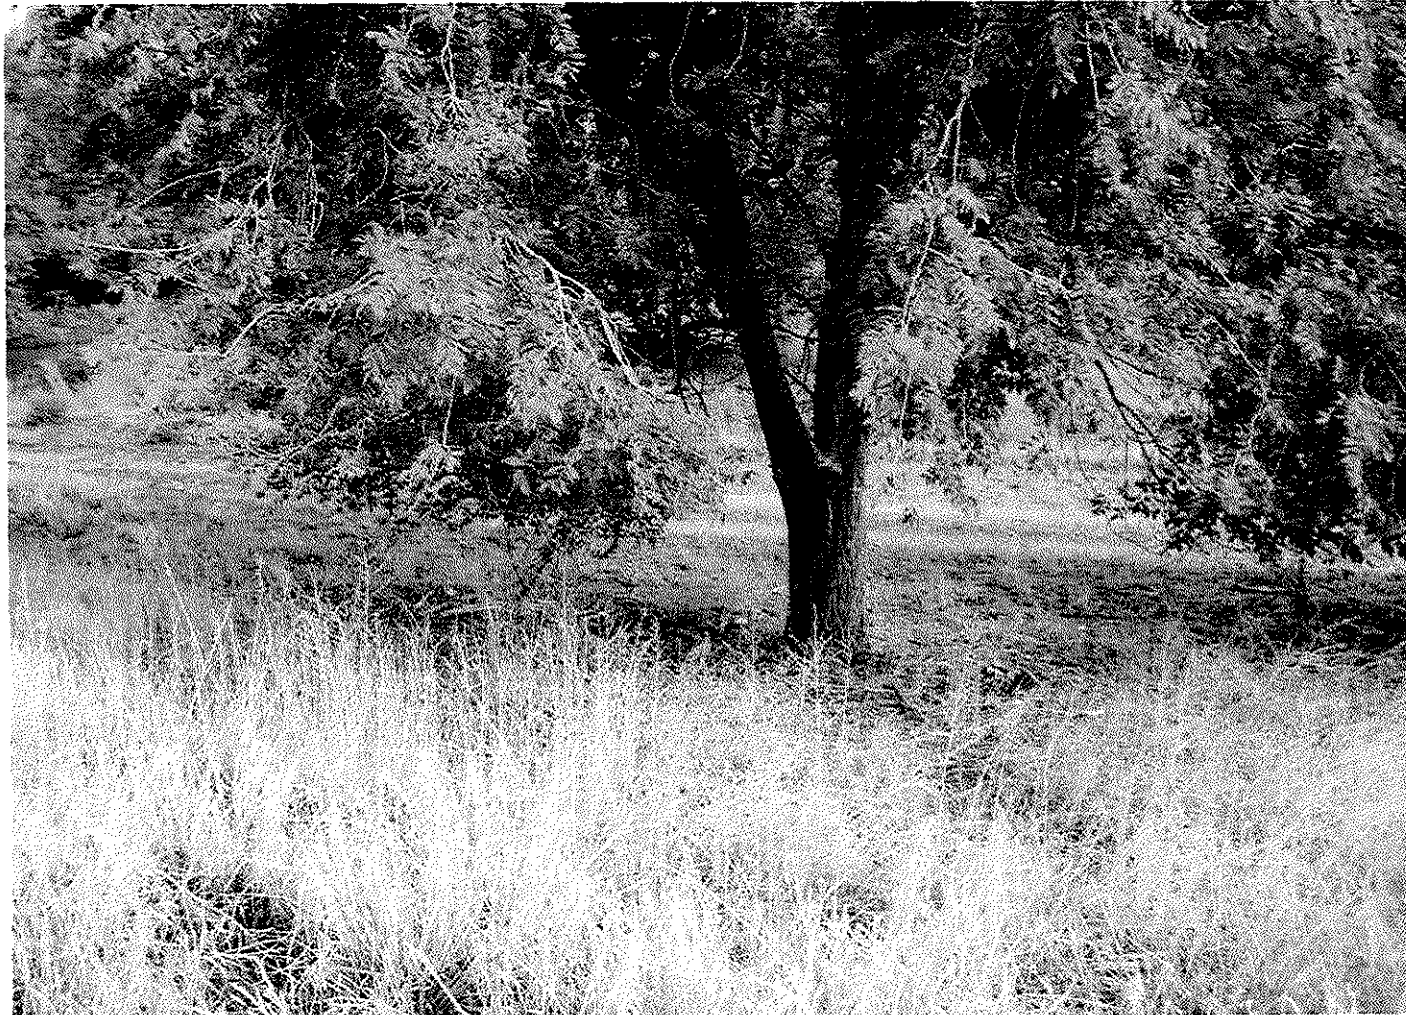
Inspect ID: 0008\_2008\_a\_0001 Name: USACE\_CESPA\_0008\_2008\_a\_0001\_2.jpg Caption: Tree at levee toe.

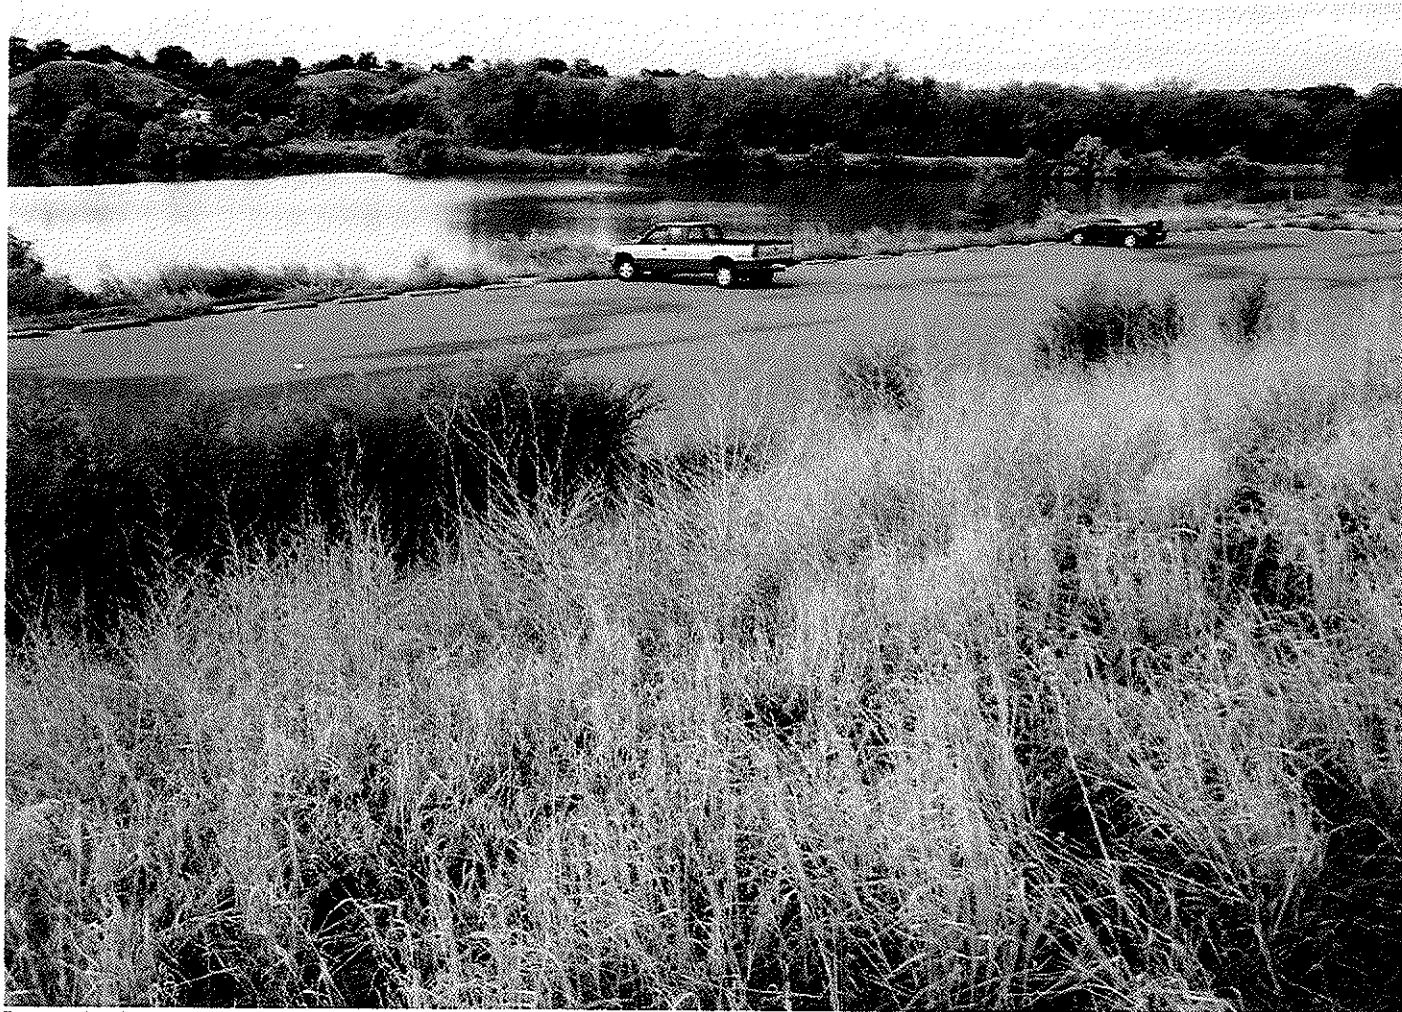
Inspect ID: 0008\_2008\_a\_0003 Name: USACE\_CESPA\_0008\_2008\_a\_0003\_1.jpg Caption: Trees growing at levee toe.

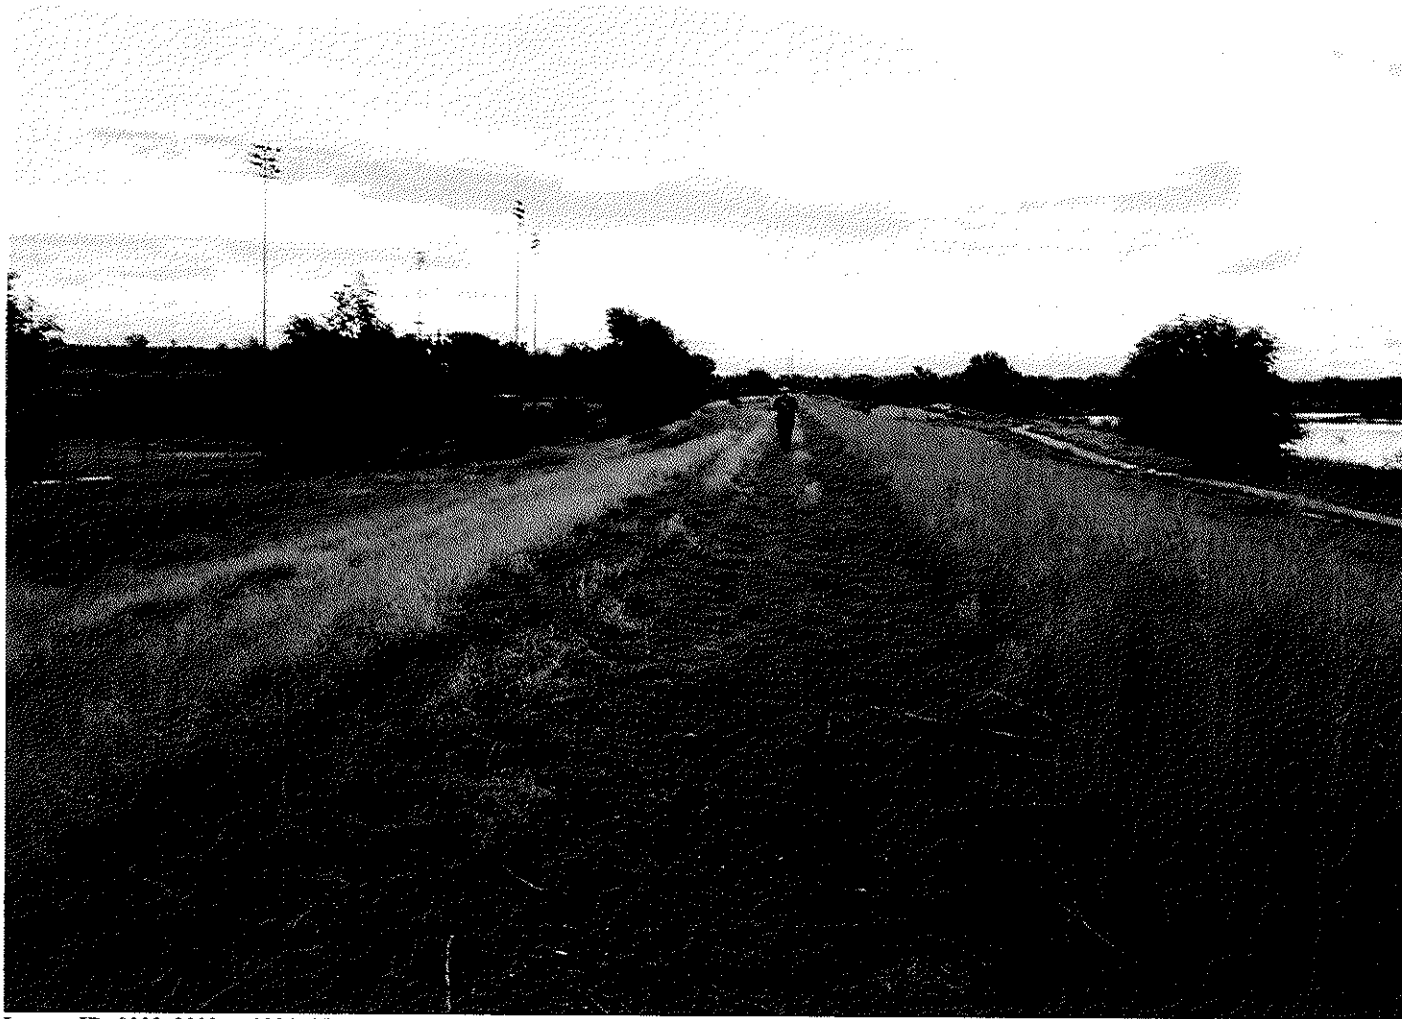
Inspect ID: 0008\_2008\_a\_0004 Name: USACE\_CESPA\_0008\_2008\_a\_0004\_1.jpg Caption: Grass needs to be mowed prior to inspection.

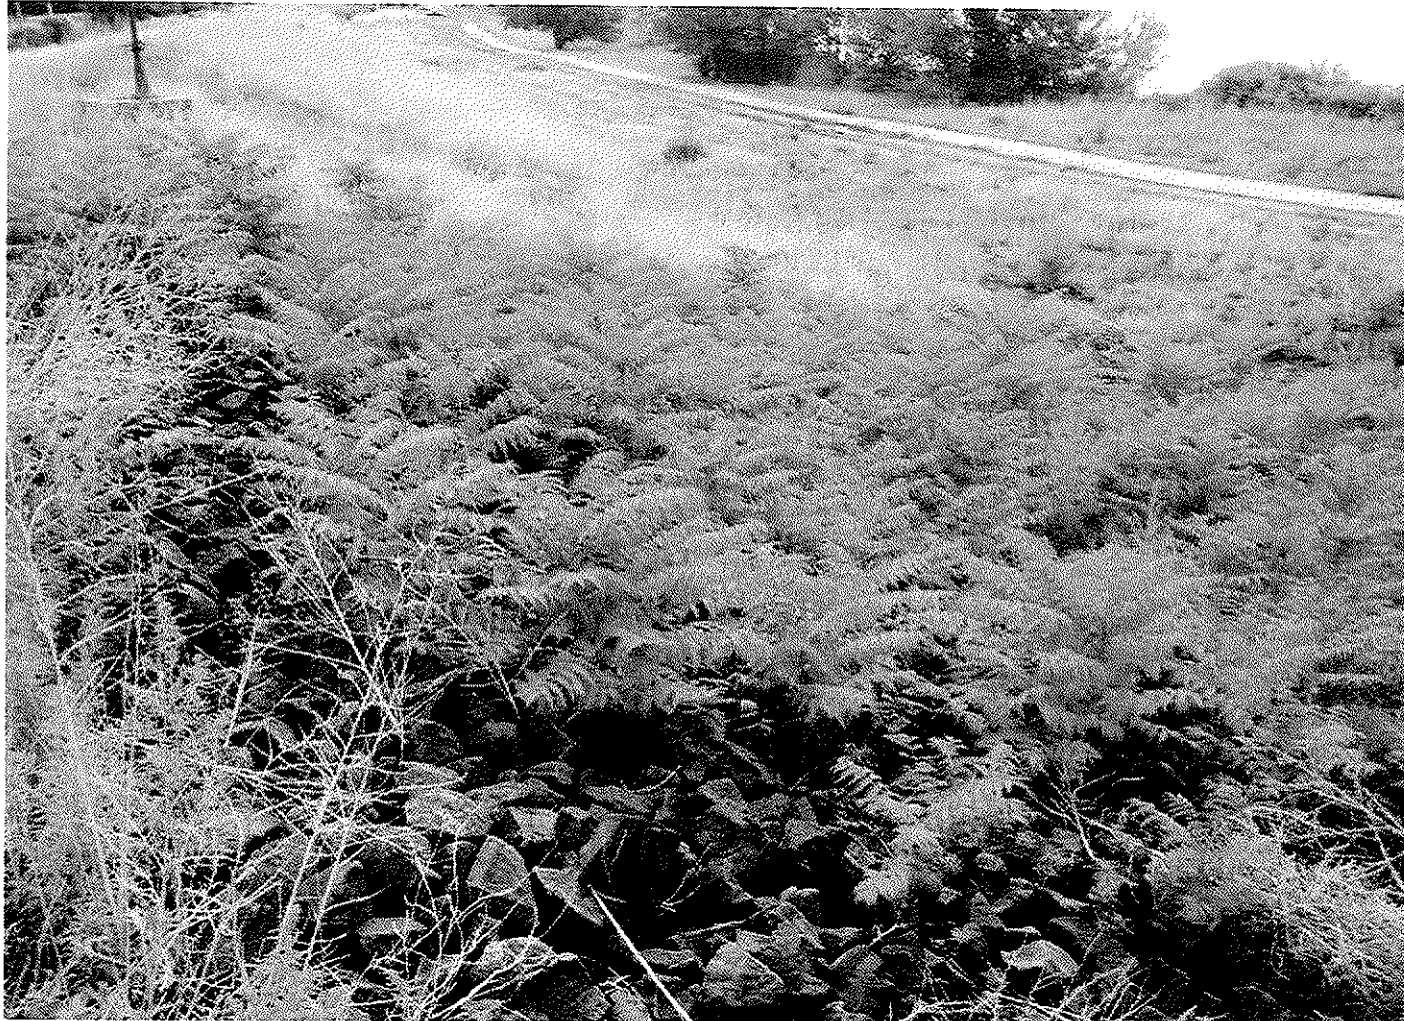
Inspect ID: 0008\_2008\_a\_0005 Name: USACE\_CESPA\_0008\_2008\_a\_0005\_1.jpg Caption: Numerous, small trees growing in rip rap slope protection.

| Rated Item | Rating | Rating Guidelines | | Location/Remarks/Recommendations |
|---|---|---|---|---|
| 12. Riprap<br>Revetments &<br>Bank Protection | <b>M</b> | <b>A</b> | No riprap displacement or stone degradation that could pose an immediate threat to the integrity of channel bank. Riprap intact with no woody vegetation present. | Small trees growing in rip rap should be removed. The quicker they are removed the easier the task will be. |

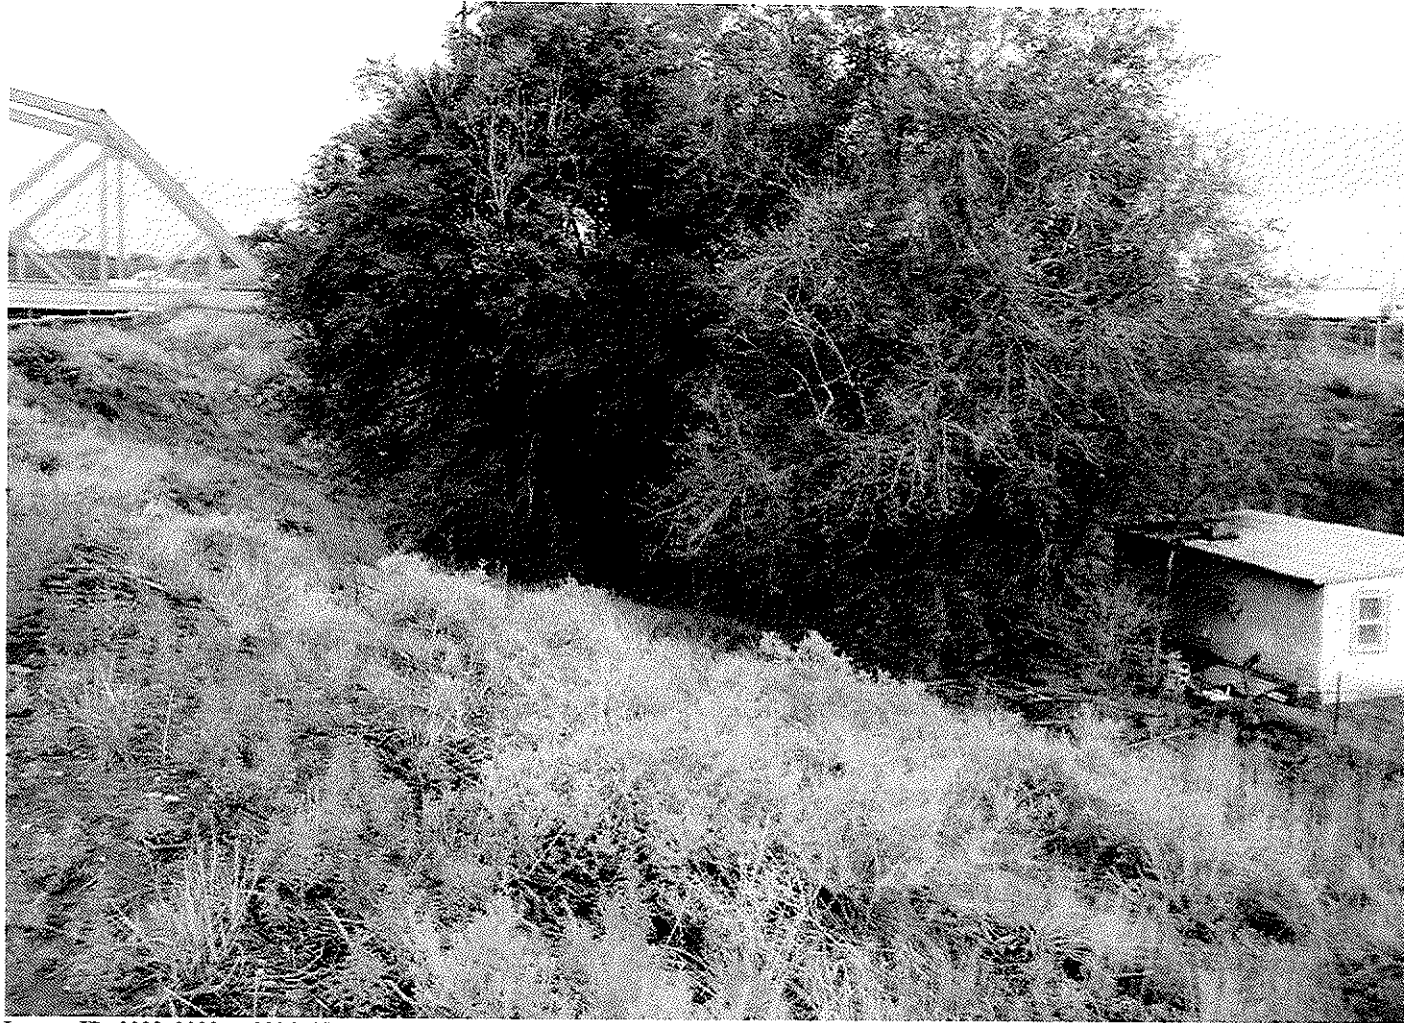
Inspect ID: 0008\_2008\_a\_0006 Name: USACE\_CESPA\_0008\_2008\_a\_0006\_1.jpg Caption: Trees at levee toe.

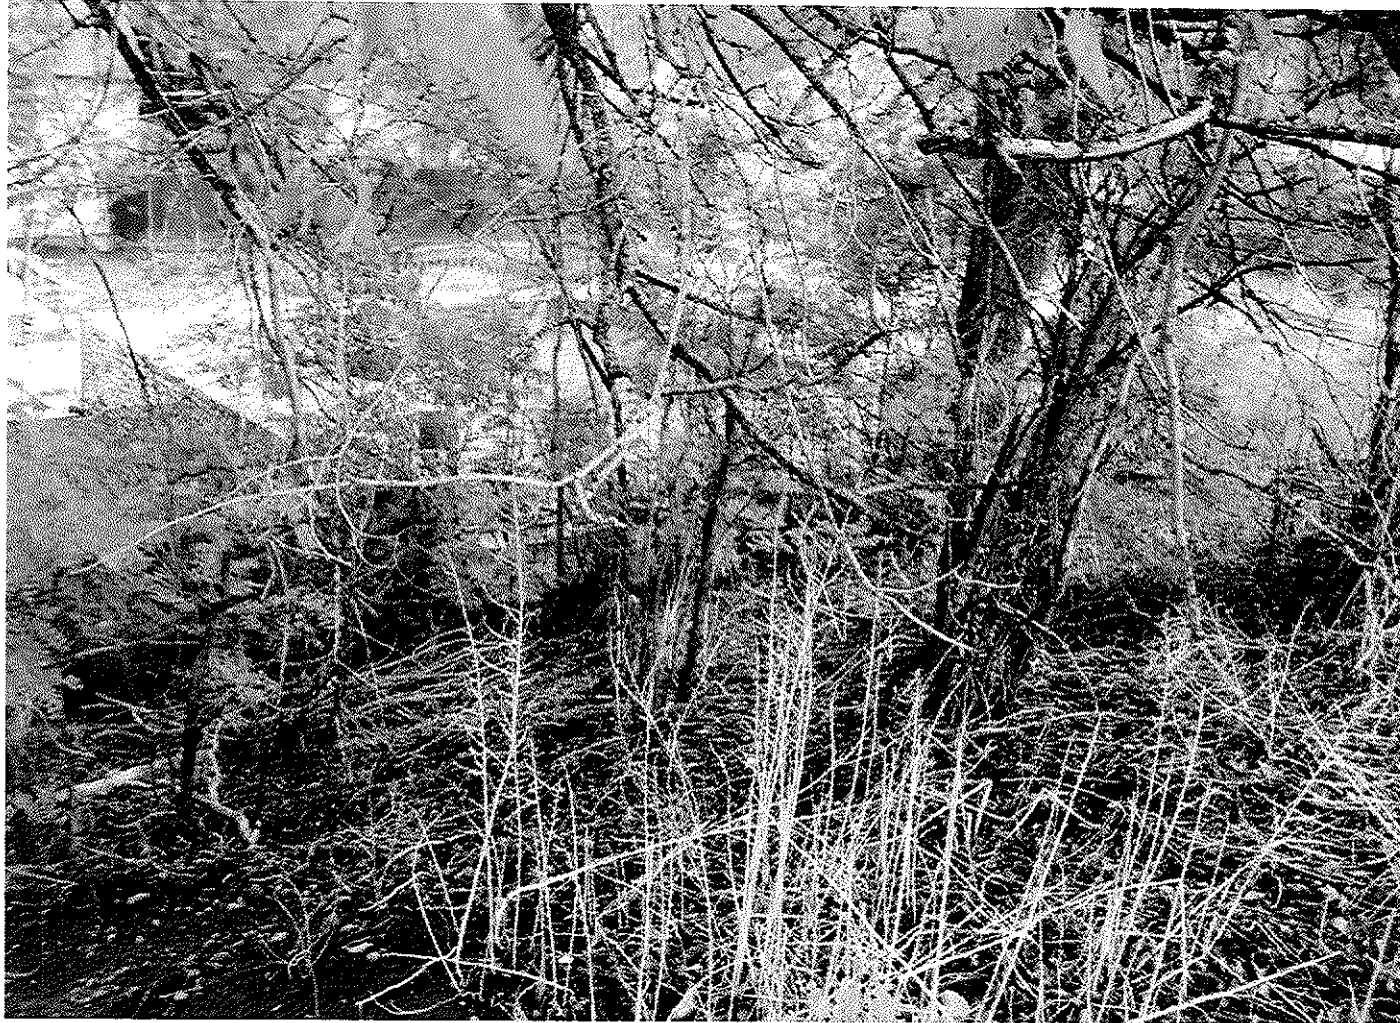
Inspect ID: 0008\_2008\_a\_0006 Name: USACE\_CESPA\_0008\_2008\_a\_0006\_2.jpg Caption: Trees growing at levee.

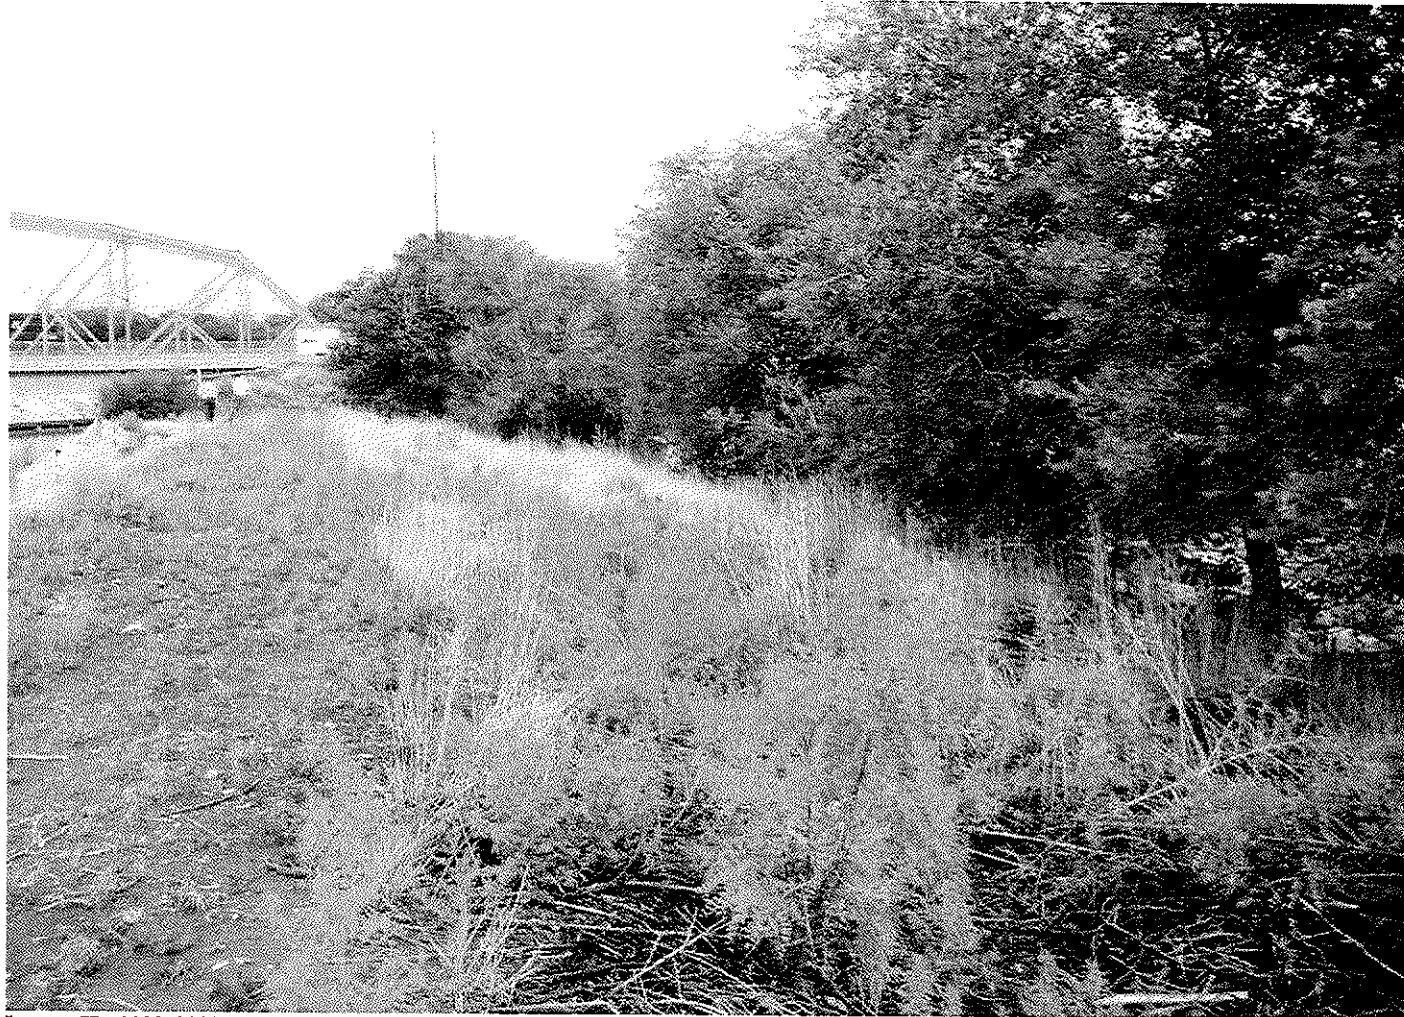
Inspect ID: 0008\_2008\_a\_0006 Name: USACE\_CESPA\_0008\_2008\_a\_0006\_3.jpg Caption: Trees growing along levee.

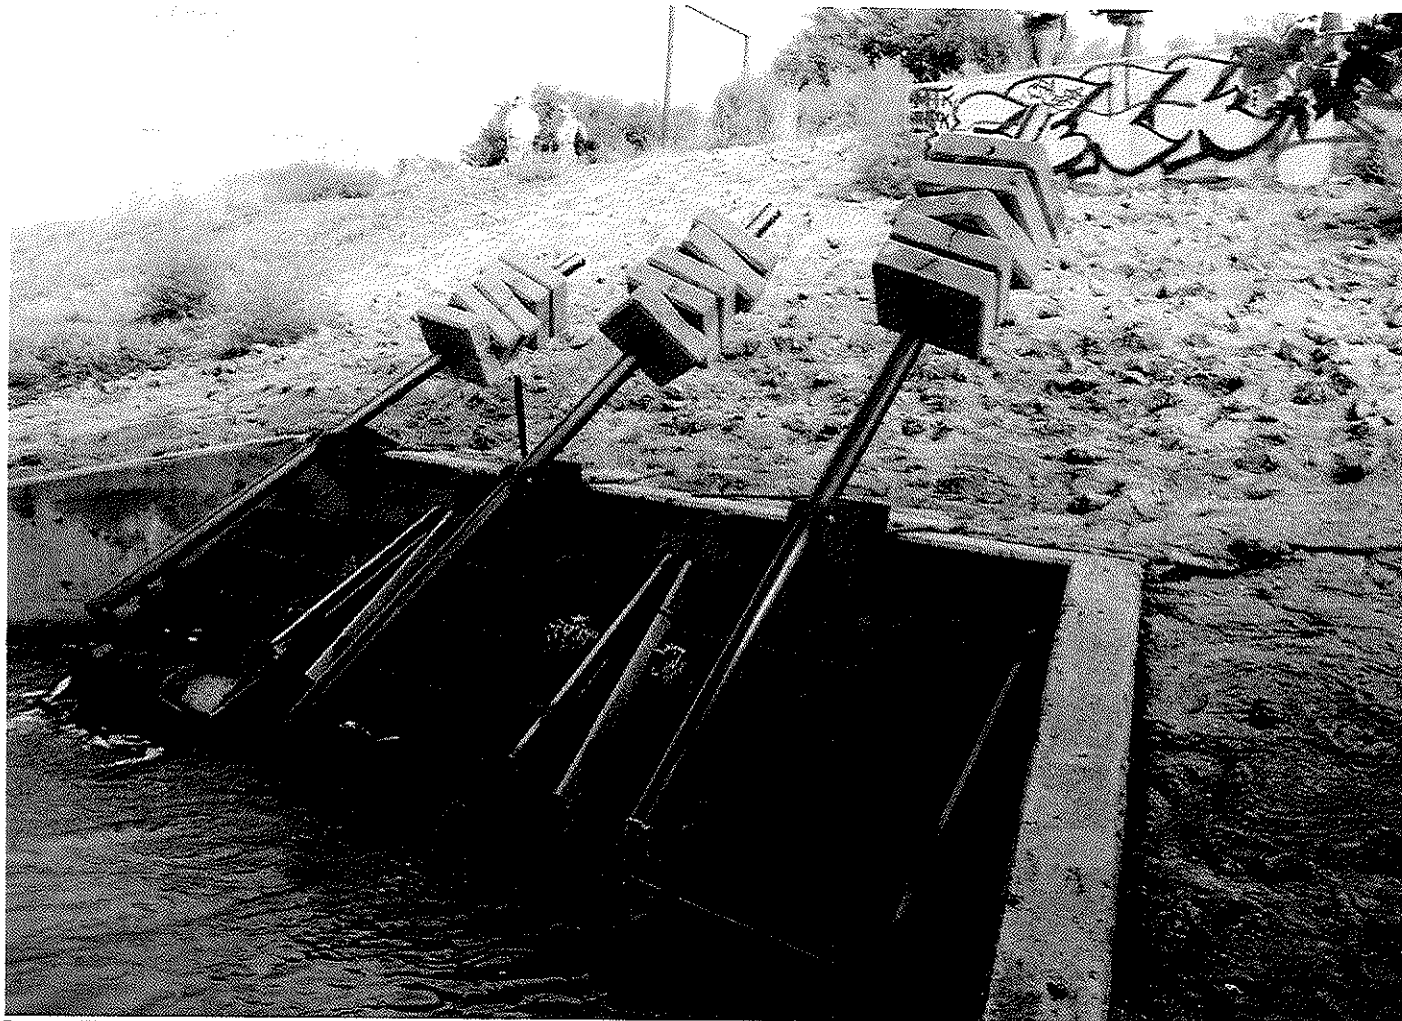
Inspect ID: 0008\_2008\_a\_0002 Name: USACE\_CESPA\_0008\_2008\_a\_0002\_1.jpg Caption: Flap gates at drainage structure.
