### MINUTES OF THE PUEBLO CONSERVANCY DISTRICT SPECIAL MEETING ON JANUARY 19, 1987

The purpose of the meeting was to have a special report from the Engineers on the progress and problems of a leak in the grade control structure construction on Santa Fe.

January 19, 1987

This letter summarizes the activities, measurements and analyses we have performed on the Santa Fe Avenue Dam during past few weeks.

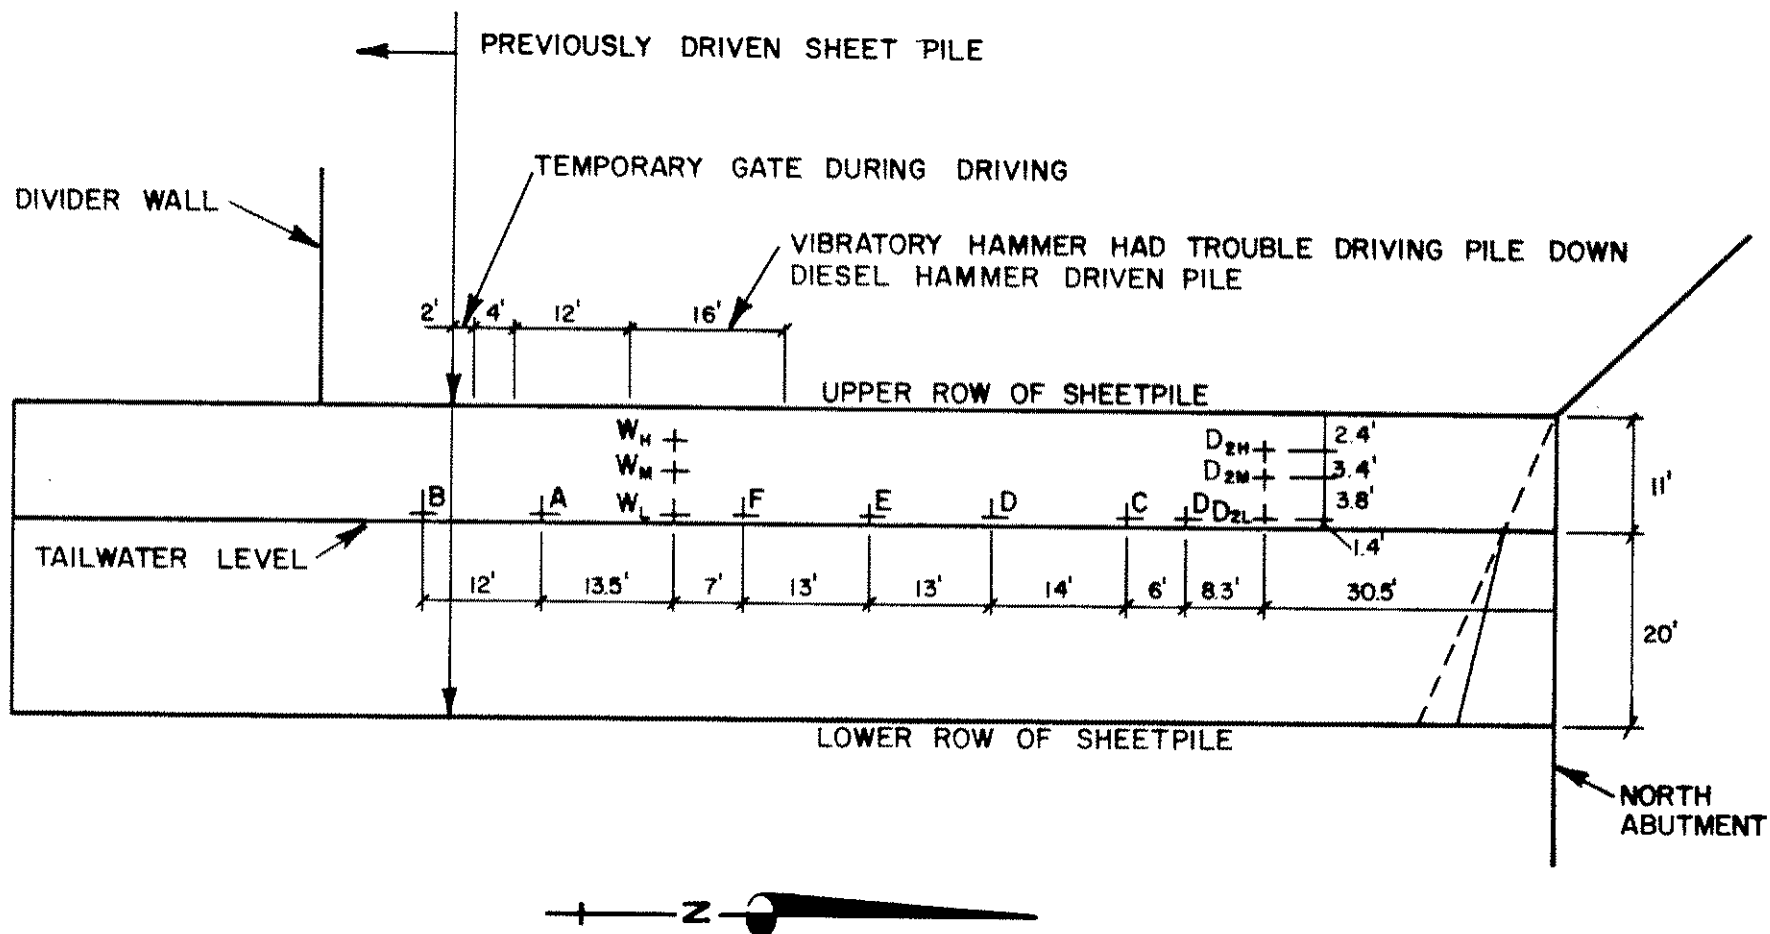
FIGURE 1  
PIEZOMETER LOCATION  
DRAWING

During the finishing stages of construction of the dam, our field inspector Mr. Greg Chol found a small amount of water leaking at an isolated point on the face of the dam. This was perceived at the time to be a possible cause for concern. Immediately we directed installation of piezometers near the location of the leak and at a few other locations on the face of the dam. The initial readings indicated higher piezometric head at the location of the leak compared to the piezometric head at other locations having the same elevation.

AT ABOUT 12:30PM THE CONTRACTOR DRILLED 3 HOLES (W<sub>1</sub>, D<sub>1</sub>, D<sub>2L</sub> ON FIG 1) IN THE DAM FACE. THE WATER RAISED TO ELEVATION 50<sup>31</sup> IN TEST HOLE W<sub>1</sub> AND IN TEST HOLE D<sub>1</sub> AND D<sub>2L</sub> IT WAS 6" BELOW THE GROUT SURFACE. THE CONTRACTOR DRILLED THE THIRD TEST HOLE BECAUSE HE THOUGHT THAT HE HAD HIT A TIE BEAM WITH THE SECOND HOLE.

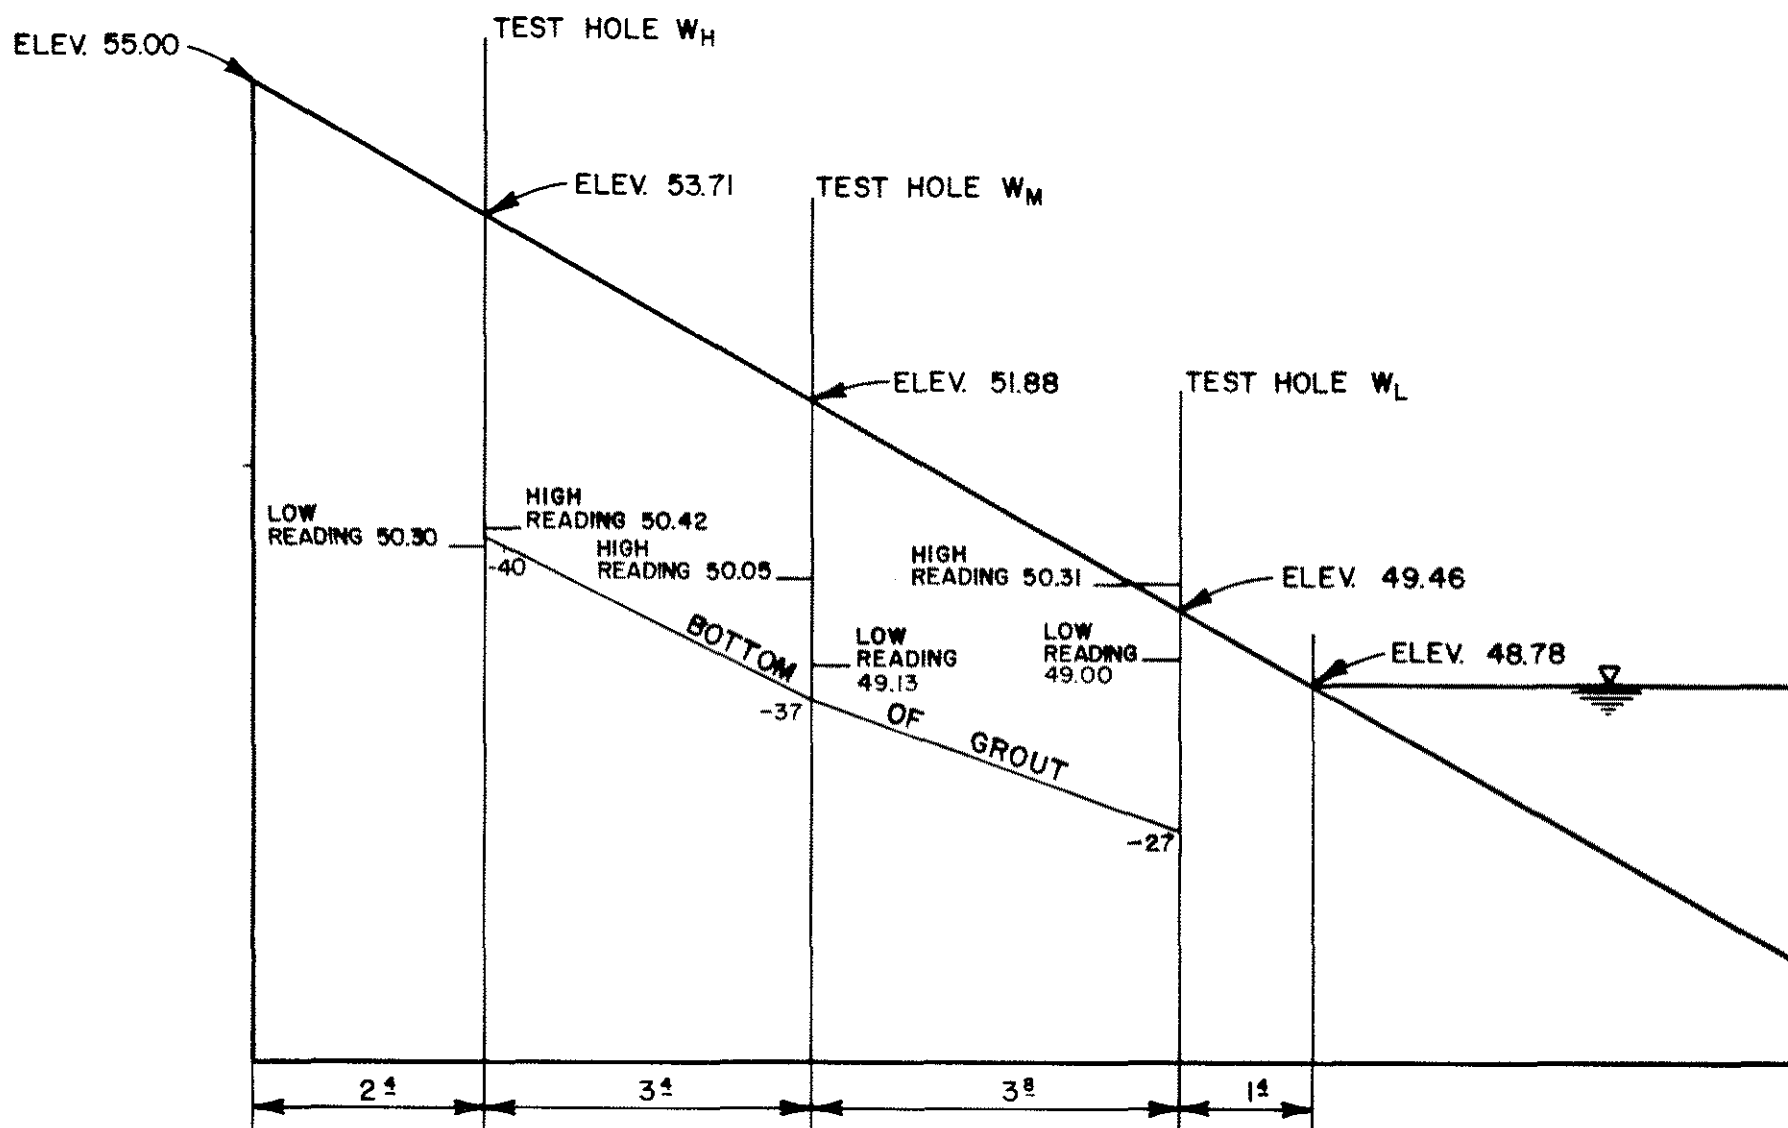
FIGURE 2  
CROSS SECTION  
TEST HOLES W

The construction records were reviewed and it was observed that sheet pile driving encountered problems in the area where the piezometric head was found higher and where the leak was occurring. In order to investigate the cause of the problem in further detail, we directed installation of piezometers along sections perpendicular to the longitudinal axis of the dam. The locations of all the piezometers installed are shown in Figure 1. The piezometer readings are summarized in Table 1. The piezometer readings were plotted along each section perpendicular to the axis of the dam and parallel to the dam axis. They are shown in Figures 2 through 4.

As can be seen from the piezometer readings, the readings have consistently gone down in all locations, eventhough the upstream water surface has varied from elevation 53.03 to elevation 55.00 (top of dam).

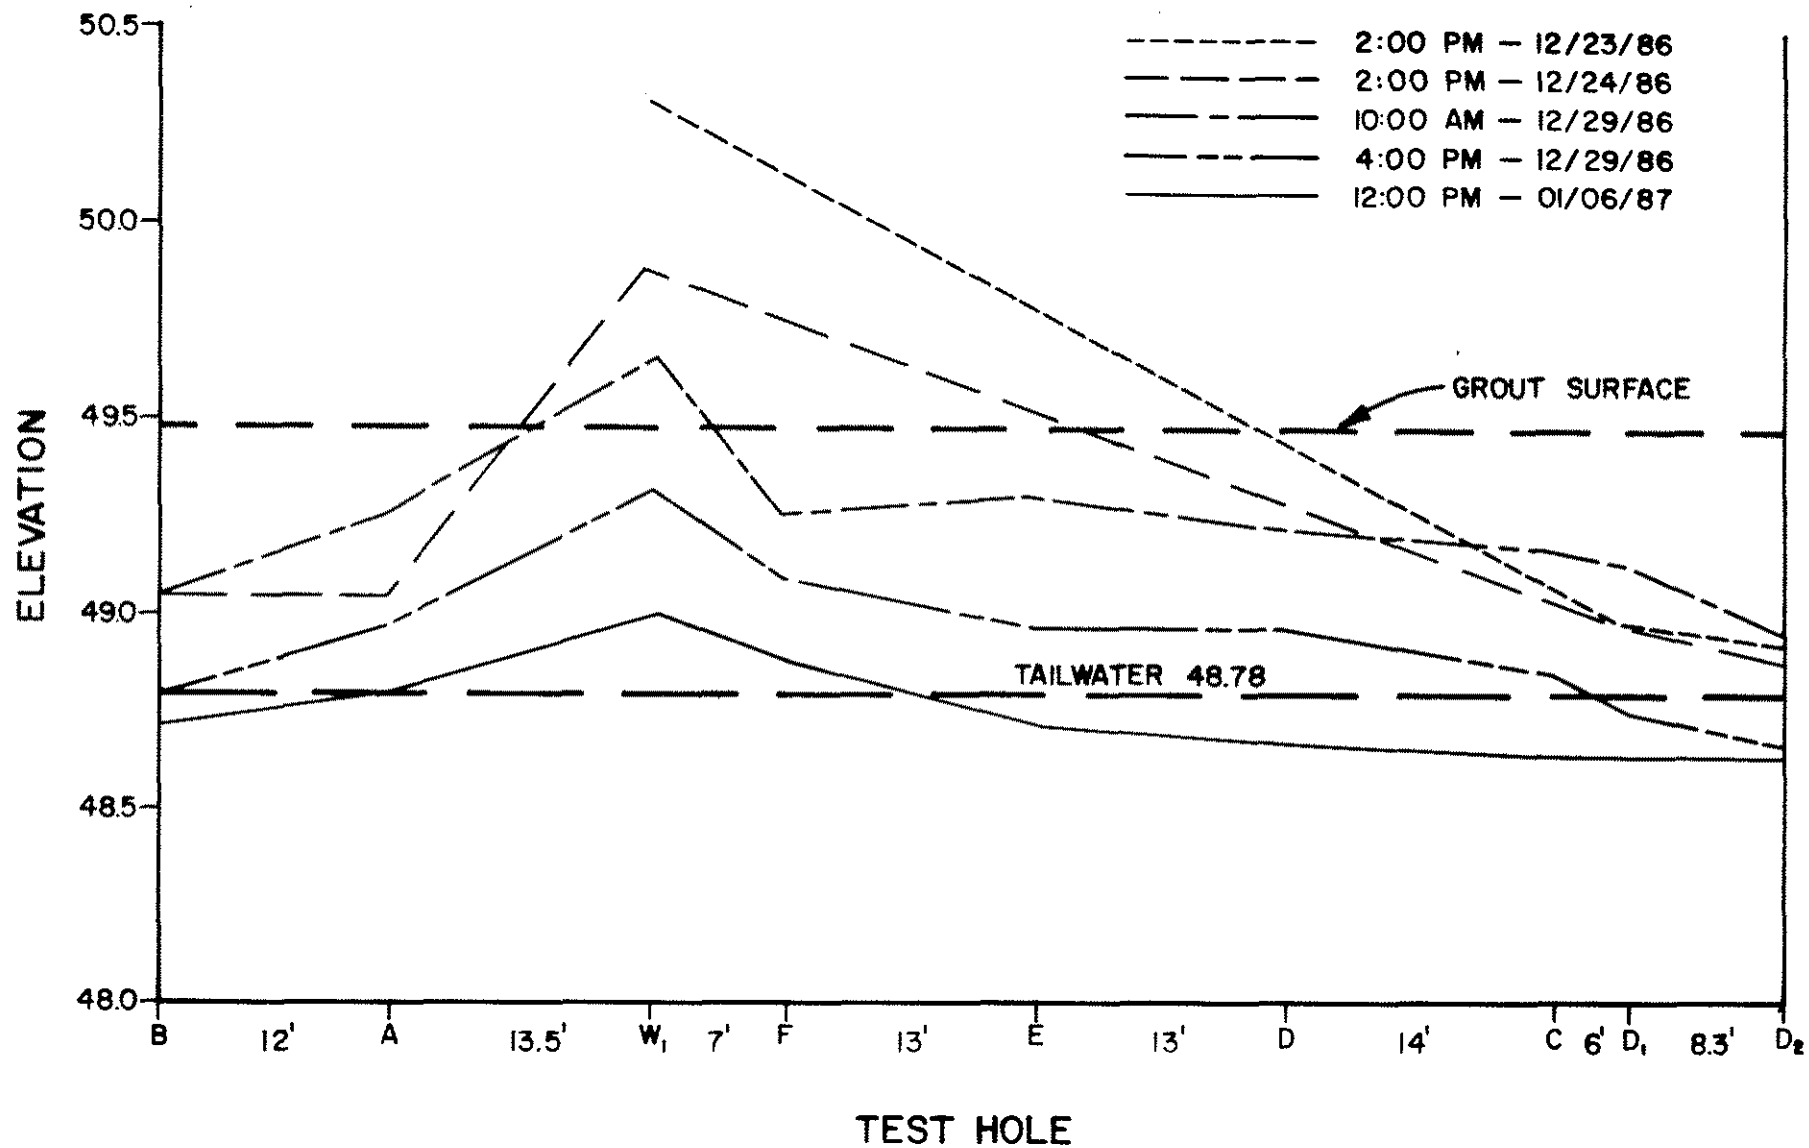
FIGURE 4  
LATERAL INTERPRETATION  
OF PIEZOMETER DATA

However, the readings have remained relatively high in the observed problem area as illustrated in Figure 4.

The consistent high piezometer readings at the trouble spot indicate that the opening through or under the upstream row of sheet piles is probably more than in the other areas of the dam. The excess flow here apparently travels laterally under the dam and discharges at the many weepholes on the downstream face. This explains the gradient away from the trouble area and could possibly indicate reduced capacity thru the weeps on the downstream row of sheet pile.

However, due to the coincidence of high piezometer readings in the area, where problems were encountered in driving the sheet piles (use of diesel hammer instead of vibratory hammer), the data implies the possibility that sheet piles might have buckled, a joint partially separated, a hole was cut (we are not aware of any), and/or the pile did not penetrate to bedrock in that area. There is always the possibility of boulders or cobbles obstructing the penetration of the sheet piles.
